FIRE PREVENTION  
AND  
FIRE PROTECTION

IN the preparation of this volume it has been the author's aim to present, in a manner suitable for ready reference, the present status of fire-resistance as applied to buildings, including not only many details of construction which, it is hoped, will prove of practical value to architects, constructionists and underwriters, but also those preventive means and those broad principles of scientific fire-protective design, without which constructive details are often of little avail. Numerous tests of materials and devices, and many descriptions of past experiences of value have also been added, in some detail, for the benefit of students or those wishing to make a more complete study of the subject.

BOSTON, *April*, 1912.

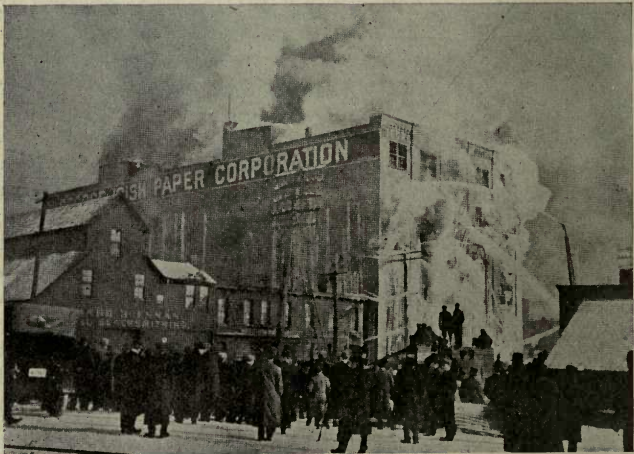
A wonderful illustration of the slow-burning qualities of slow-burning construction was afforded by the fire which destroyed

FIG. 3. — Fire in Mill Construction Warehouse of the George Irish Paper Corporation, Buffalo, N. Y.

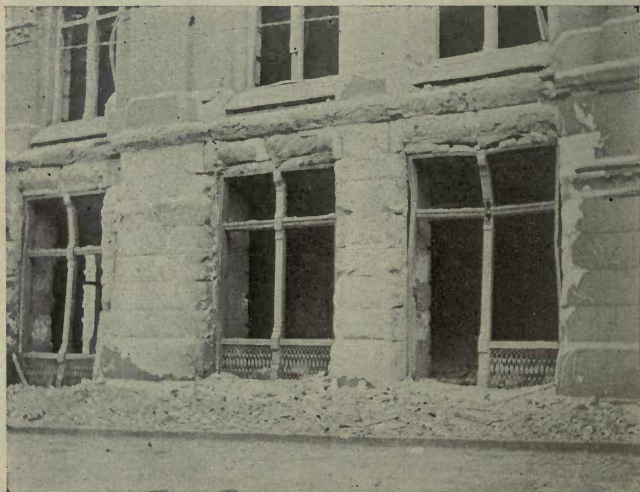
FIG. 37. — Façade of Baltimore & Ohio Railroad Co's. Building, Baltimore Fire.

In the former class were the Chamber of Commerce and the Baltimore and Ohio Railroad Office Building. A photograph of the lower stories of the latter building is shown in Fig. 37, illustrating the great damage done the exterior granite work.

Many fires have caused great damage to limestone, marble and granite façades, as in the Chicago Athletic Club Building, the Home Life Building, and very many other structures in Baltimore, San Francisco, etc. Fig. 37 illustrates the condition of the first story granite walls of the Baltimore and Ohio Railroad Company's Building after the Baltimore fire, and Fig. 36 shows a marble column in the entrance rotunda of the Calvert Building after the same fire. Such experiences point to the desirability of employing the pure skeleton construction if the use of stone is introduced to secure architectural effects. The stonework would then be free from any load-carrying functions, and the walls would be divided story by story. Damaged material could be replaced without disturbing unaffected areas.

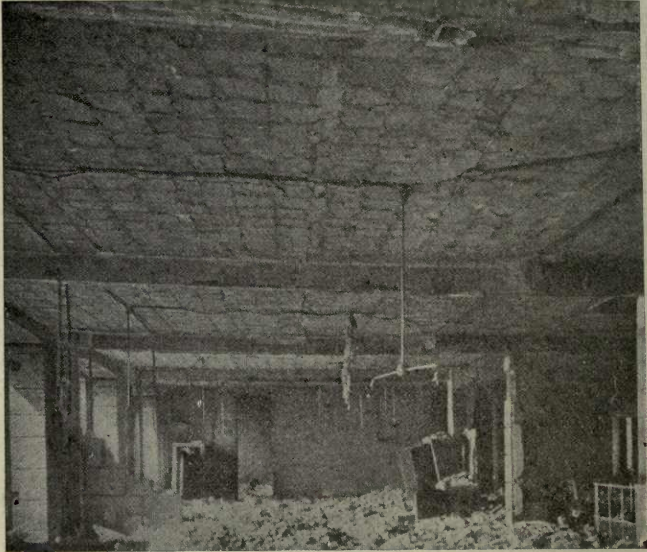
On the interior, wood floors and screeds had entirely disappeared, and the cinder concrete filling was soft and lifeless. Although all of the end-construction porous terra-cotta floor arches were in place, they were devoid of ceiling plastering, and arches were cracked and sagged in the center to a considerable extent on several floors. This was due to faults in the floor

FIG. 39. — Interior of Herald Building, Baltimore Fire.

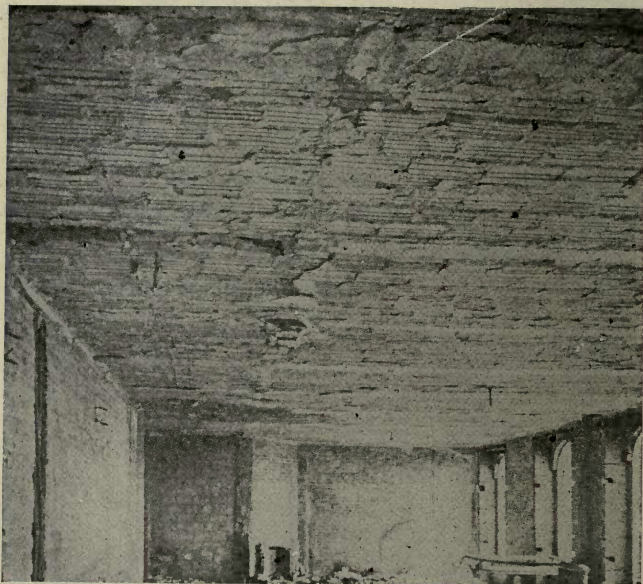
FIG. 40. — Interior of Chesapeake & Potomac Telephone Building, Baltimore Fire.

The blocks were of old-style Raritan manufacture, porous, side construction, 10 inches deep, but of small size and thick webs. The setting had evidently been carefully and conscientiously done. Excepting some of the lower faces which were broken off on the sixth floor where the fire was very hot, the arches were in almost perfect condition (see Fig. 40).

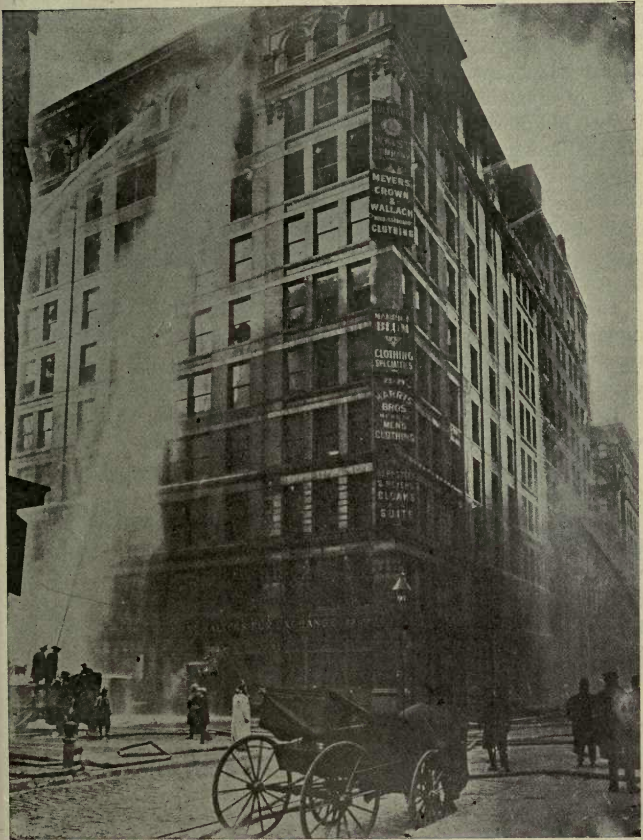
FIG. 41. — Asch Building Fire, New York.

"Note the ineffectiveness of the powerful hose stream directed from the street toward the window on the 10th floor. The portion of a stream shown at the extreme left is from a water tower. This enters the 10th floor at a somewhat more effective angle, but still ineffective a few feet back from the window. The two small streams entering the 10th floor, as shown in the upper right hand corner of the picture, are directed from a building across a fifty-foot street."

*The Building*\* is a ten-story loft building, built in 1900-1901, situated at the corner of Washington place and Greene street, New York City (see Fig. 41). The lot area is practically 100 feet square which, less open courts on two sides, leaves typical floor areas of about 9000 square feet. The construction is as usual in such buildings in New York, *viz.*, cast-iron protected columns, steel girders and floor beams, protected by hollow tile arches.

*Third:* The importance of fire towers suitable for the prompt escape of the occupants and likewise to afford the Fire Department a safe station from which to efficiently fight fires at close range. Note that the powerful stream directed from the street toward the tenth story (as shown in Fig. 41) is practically vertical and cannot possibly reach a fire on the inside even a few feet back from the windows.

The possible waste of water and the inability of hose streams to penetrate any considerable distance beyond the windows were well exemplified in the Asch Building fire in New York. Fig. 41 admirably illustrates how both waste and inefficiency increase with the building's height.

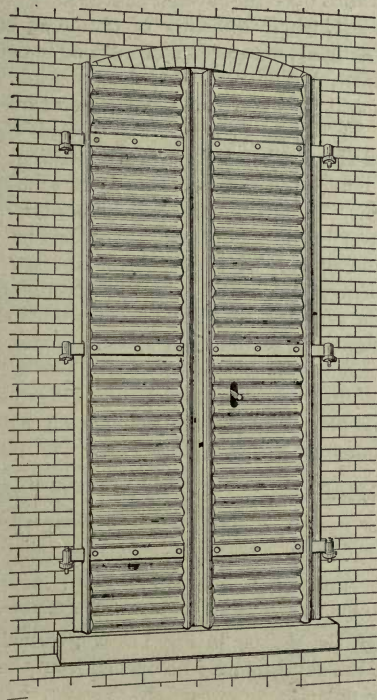
Continuous welded frames and cross bars of  $1\frac{1}{2}$ - by  $\frac{1}{2}$ -inch iron are often used, but are not considered the full equivalent of the angle-iron frame. The welded frame is often necessary when folding shutters are used.

FIG. 118. — "Saino" Corrugated-iron Fire Shutter.

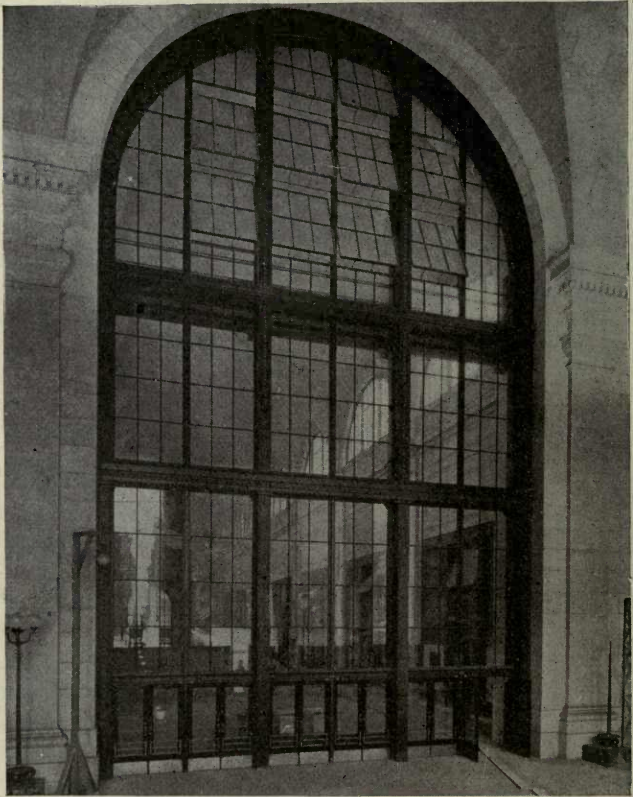
FIG. 127. — Cast-iron Entrance Screen, Pennsylvania Railroad Station, N. Y.

horizontal operating rods which may easily be controlled from the floor level. A typical arrangement of this character, but without wire glass, is illustrated in Fig. 127 which shows an entrance screen at the new Pennsylvania Railroad station, New York.

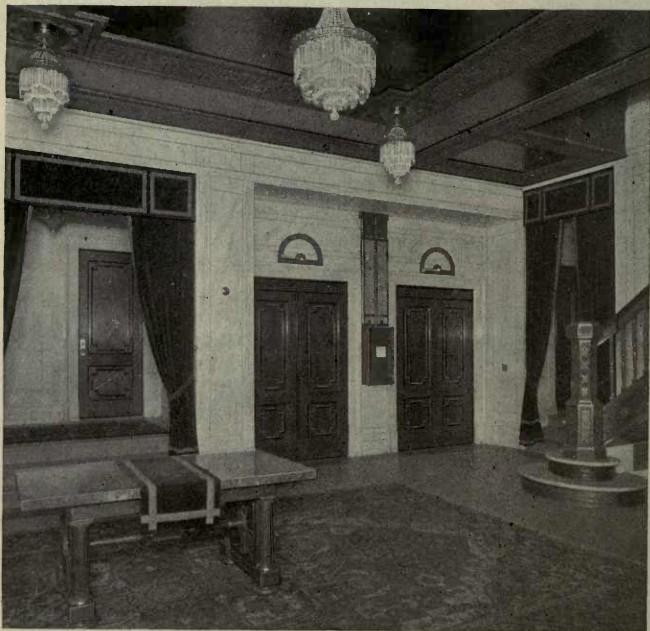
FIG. 144. — "Dahlstrom" Elevator Doors, Forest Chambers Apartments, N. Y.

City, are of the Dahlstrom metallic type. Fig. 143 gives a section through a typical door, with four different styles of casings (for trim, etc., see later paragraph). Fig. 144 illustrates the Dahlstrom combination slide-and-swing elevator doors, as used in the Forest Chambers Apartments, Broadway and 113th

From the standpoint of fire protection, however, no type of elevator enclosure is comparable to a solid brick or concrete wall. Rigidity and stability are especially desirable.\* Doors suitable for use with such enclosures have been described in Chapter XIV (see especially Figs. 144 and 145); but solid doors are open to the objection that the car operator cannot see passengers waiting at the floor levels, while small observation holes of glass in the doors, or even glass upper panels, do not give the elevator operators that quick and complete view of waiting passengers which insures quick and safe service. Also, customers, tenants and the public generally like to obtain a full view of the cars as they ascend and descend the shafts. Indicators or flashlights may designate the floors at which the various elevator cars are passing

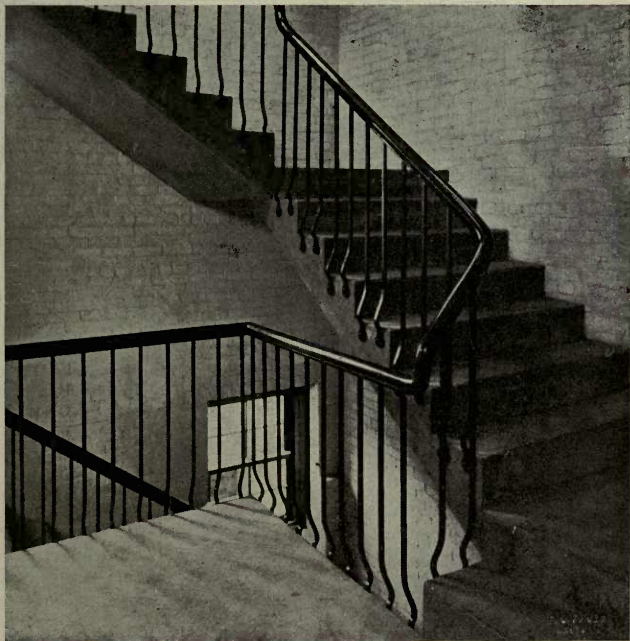
FIG. 175. — Concrete Stairs, Walter Baker Co.'s Building, Boston.

The first method is more commonly employed, especially for runs not over 8 to 10 feet in length measured on the slope. Fig. 175\* illustrates a stair of this type used in the Walter Baker

Company's Building, Boston, while Fig. 176 also illustrates a slab-method concrete stairs, as used in the United States Assay Office, New York. For such examples, a slab thickness of 5 inches measured at the foot of the risers, as shown in Fig. 176, is sufficient for a run of half the height of an ordinary story. The principal reinforcement consists of  $\frac{5}{8}$ -inch round rods spaced 6 inches centers, hooked over the floor and landing beams, while

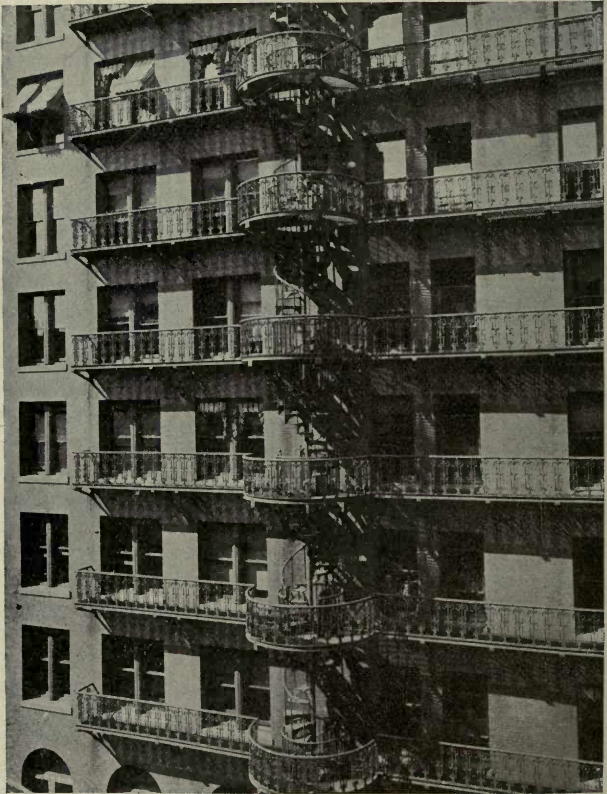
FIG. 183. — Circular Stair Fire Escape, Pemberton Building, Boston.

**Circular Fire Escapes.** — Where something better or more architectural than the ordinary zig-zag fire escape is desired, circular stairs may be employed. Fig. 183 illustrates a very pleasing and efficient arrangement, as used on the rear of the Pemberton Building, Boston, Fehmer and Page, architects. It will be noted that the stairs are fairly well protected by a blank wall area, so that when people have once gained the stairs, no windows are passed. The principal disadvantage to this arrangement is the dizziness which may result from descending many flights rapidly. To prevent pitching forward and over the stair railing from dizziness, such stairs are frequently enclosed by means of wire netting, or rods at intervals of 4 to 6 inches, run from the top of railing to the under side of the treads above.

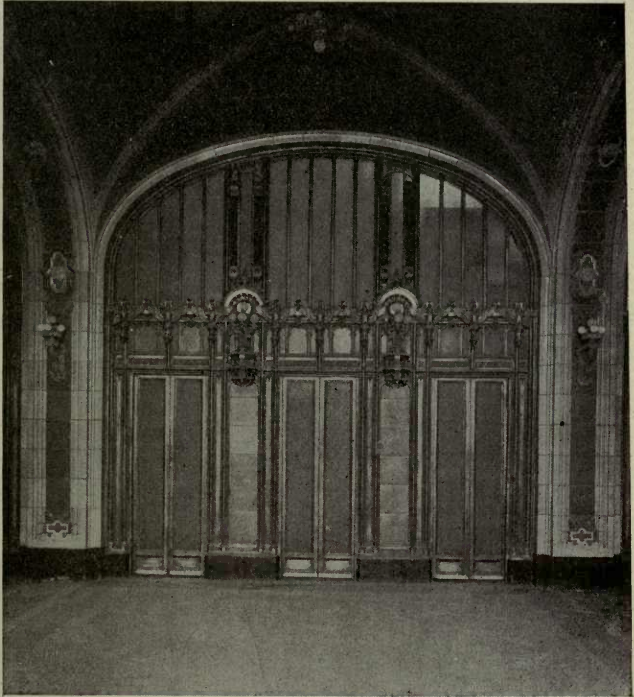
FIG. 186. — First Story Elevator Fronts, West St. Building, N. Y., Cass Gilbert, Architect.

The past several years have witnessed the installation of many wire glass elevator enclosures, especially in office buildings, hotels and apartment houses, and this type may now fairly be considered the standard in this type of structures.
